Earthquake Damage Intensity Relationship for Residential Houses in West Sumatra

EARTHQUAKE DAMAGE INTENSITY RELATIONSHIP FOR RESIDENTIAL HOUSES IN WEST SUMATRA

Febrin Anas Ismail^{*)}, Abdul Hakam, and Fauzan

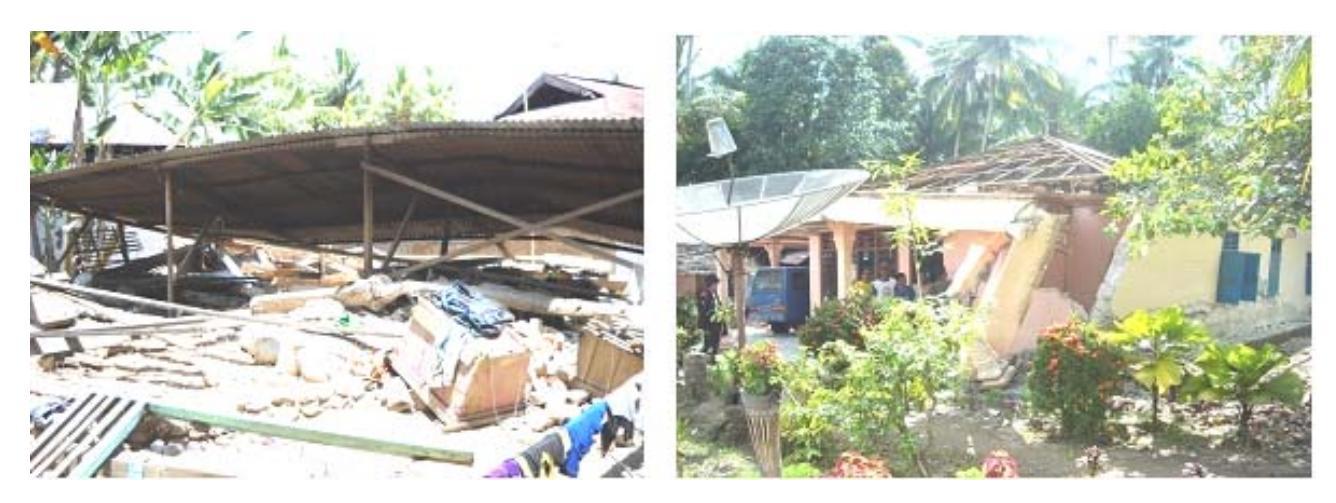
Figure 3. A Heavily Damage Houses

Determination of the extent of building damage was done by visual observation. Based on the visual observation, the affected buildings can be classified according to three level of damage which follows the Indonesia government criteria. There are three initial given for the damaged building: RB for a heavily damaged building/house, RS for a house with a level of moderate and RR for the slightly damaged house. For the example, the condition of a house that referred to be suffering from heavily damage is shown in Figure 3.

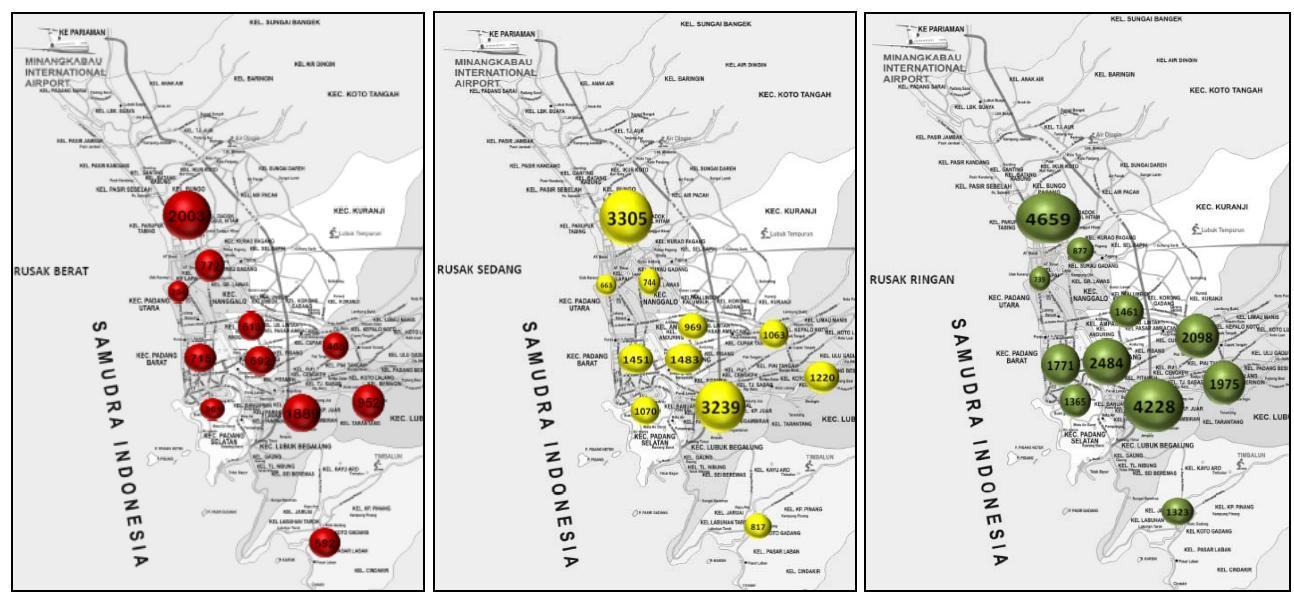
Figure 4. Damage Houses in Padang

This paper shows the plot results of survey of the damage homes in Padang. The results are displayed in the term of map which is divided by districts in the city. Figure 4a, 4b, and 4c show damage to the residential

houses with the category of heavily, moderate and slightly for the city. In every figure, the number that indicated the damaged houses is displayed in. The size of the bubble also presents of the ratio damage in each district. It seems that there is quite diverse spread of damage to the house. However this spreading data may be figuring the seismic ground condition that has been reported by Sengara *et al.* in 2009 [8] (Figure 5).

a. Heavily damage

b. Moderately damage

c. Slightly damage

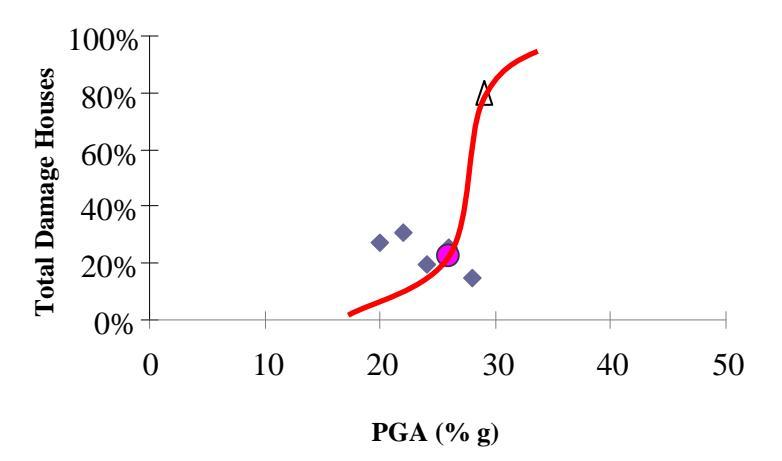
Figure 6. Damage and Earthquake Acceleration, Padang in Average (\bigcirc), Padang in Districts Area (\blacklozenge), Pariaman in Average (\triangle)

Furthermore, by dividing the area based on the level of earthquake intensity, it can display a graph of the distribution of damage to houses related to the peak ground acceleration. In the Figure 6 can be seen that there may relationship between the percentage the earthquake intensity with the distribution of the damage. In the figures also plotted the percentage of damaged houses in the city of Pariaman where located only a teens kilometres from the epicentre. The straight line curve is built in the figure to fit the relation between the damage level and the earthquake intensity in West Sumatra.

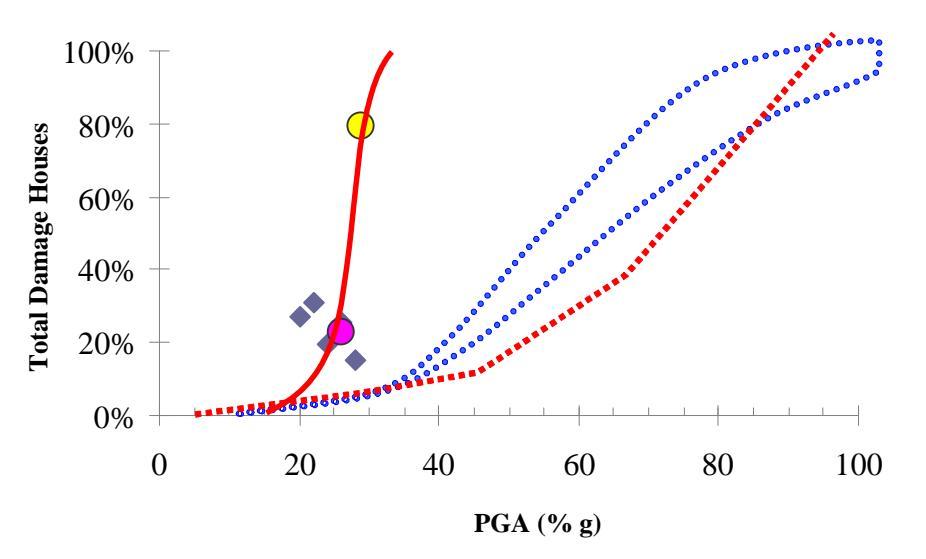
Figure 7. Earthquake Damage Intensity Relationship, West Sumatra (----), Sengara, 2011 (•••), Birss, 1985 (•••)

The results of Birss and Sengara both for brickwork structures then are plotted together with the results of this study (Figure 7). It can be seen that the predicted curves given by the other authors give over estimate to the strength of the brick masonry houses in West Sumatra.

In realty the quality of residential houses in West Sumatra depends three main factors that are: a) The quality of materials, such as the strength of the bricks; b) The process of the construction which including the skill of the worker and material composition, and c) The detailing of the construction that including the connectivity and dimension of the element of the residential structures.

It can be concluded that the quality of the residential houses in West Sumatra are very poor. The earthquake intensity to destroy the houses in West Sumatra is lower compared to the New Zealand or the other place in Indonesia.
