Evaluation of Universitas Indonesia's Recharge Pond Performance and Potential Utilization for Raw Water Source

EVALUATION OF UNIVERSITAS INDONESIA'S RECHARGE POND PERFORMANCE AND POTENTIAL UTILIZATION FOR RAW WATER SOURCE

Nyoman Suwartha[*] and Resky Agaslian Pramadin

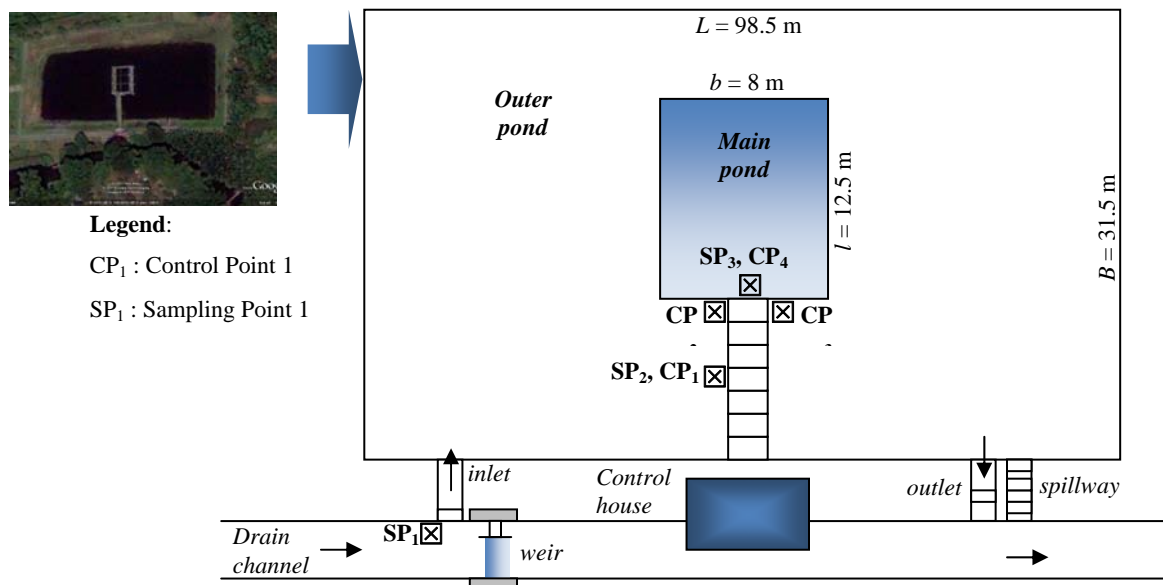
Figure 1. Location of the Control Point and Sampling Point

Hydrometric measurements. Observation at the field covers identifying current condition of water discharge, intake channel, solid waste, outlet channel, spill channel, pond banks, and land cover. The water depth is measured using conventional measuring ropes, and conducted for 11 times during the measurement period. The location of measurement is distributed into four control points inside the recharge pond to get the averaged water depth of the pond; three points at the outer pond (CP_1, CP_2, CP_3), and one point at the main pond (CP_4) as shown in Figure 1.

Water sampling. Three sampling points is determined to understand the water quality condition outside recharge pond; before the inlet channel (SP_1) and inside recharge pond; at the outer pond (SP_2) and at the main pond (SP_3) as shown in Figure 1.

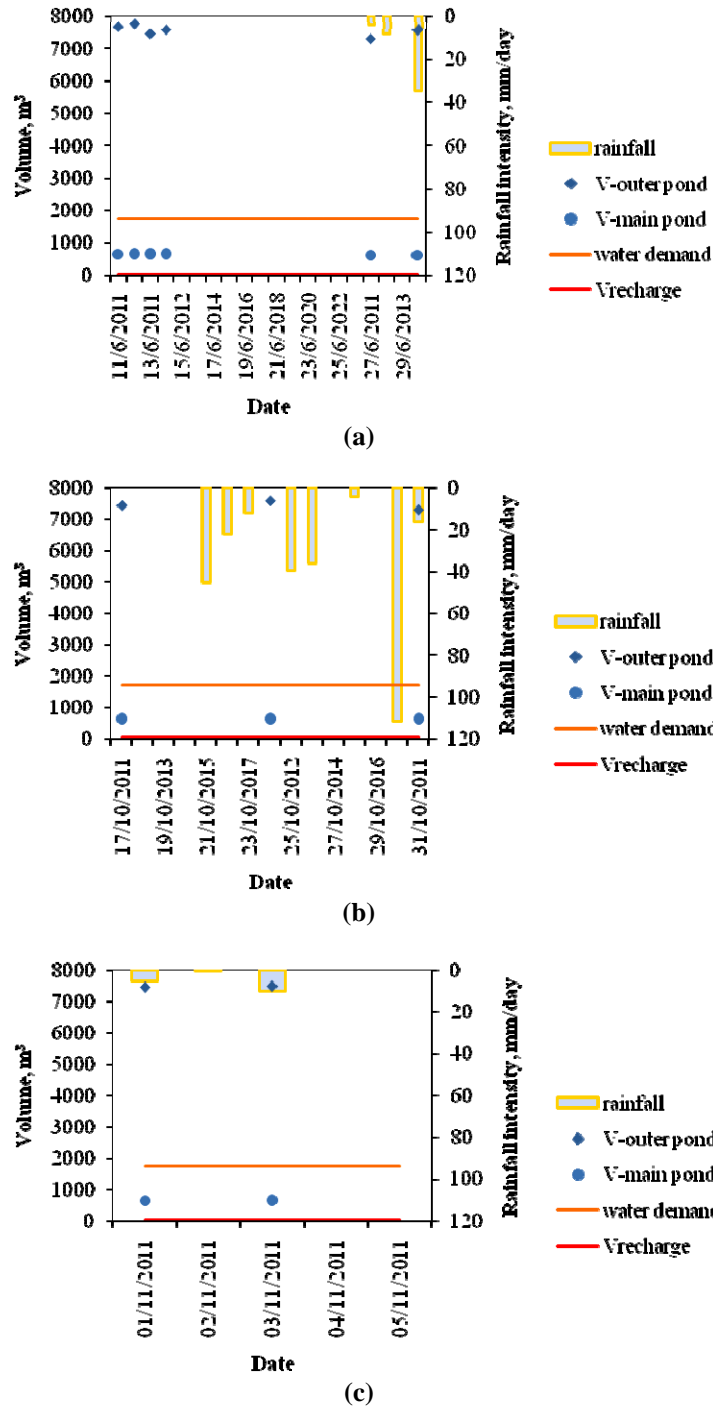
Figure 2. Water Balance of the Recharge Pond on; (a) June, (b) October, and (c) November 2011

It can be seen from Figure 2, the water balance (volume of water availability – volume of water demand – volume of recharge) of the recharge pond during measurement period is "positive", which means excessive water (surplus). Therefore, suppose that the supply discharge into recharge pond could be maintain as much as possible meet the stable storage volume, the

recharge pond is very potential to be utilized as raw water source to fulfilling domestic water demand of 30 liter percapita perday at UI Campus Depok area.
