Damage Stability Study of A 500 DW Ro-Ro Ferry Vessel

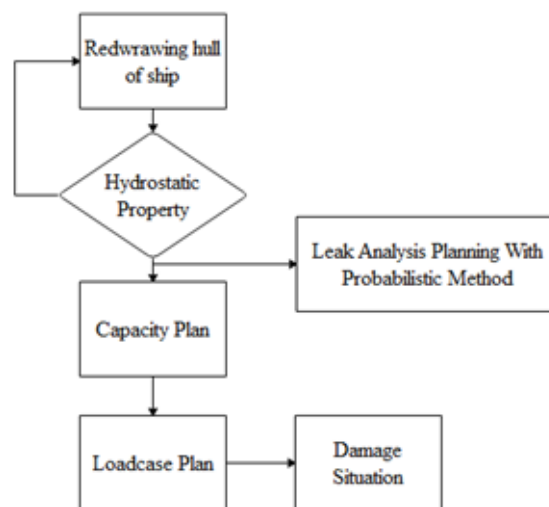
Figure 1. Steps for Damage Stability Calculation

The triangles in figure 1 illustrate the possibility of single and multiple zones of damage on a ship with a watertight arrangement suitable for the division of seven zones [8].

The triangles on the bottom line indicate single-zone damage, and the parallelogram indicates adjacent-zone damage [9].

the ship, the coefficient block, and the LS's LWL. The tolerance of the difference between the ship model and the actual data is less than 5%; the manufacture of tanks uses Maxsurf stability software. The location and coordinates of the tank points refer to the initial tank design, namely the 500 DWT Ro-Ro ferry. Next, the capacity planning of adjusted tanks to that of the ship's cargo is conducted. Load case planning is adjusted to the leak scenario before its usage. Afterward, damage stability is simulated using Maxsurf stability software on the probabilistic damage stability menu [10]. The steps for damage stability calculation are shown in Figure 1.

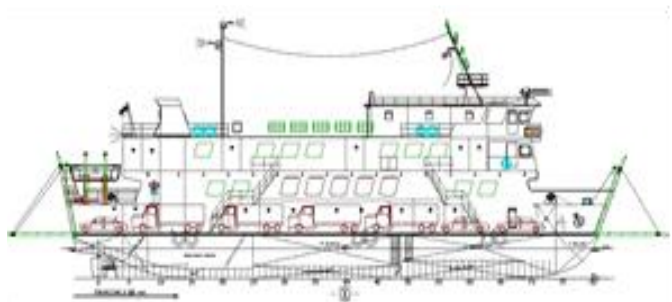
Figure 2. Sample General Arrangement of the 500 DWT Ro-Ro Ferry

The 500 DWT Ro-Ro ferry ship comprises the following payload capacities: 7 units of sedan cars, 12 units of trucks, 202 passengers, and 18 crew. The fuel tank is on a double bottom located in front of the engine room bulkhead with a capacity of 58 tons. The freshwater tank on the double bottom is located in the midship with a capacity of 32 tons. General Arrangement of the 500 DWT Ro-Ro Ferry are shown in Figure 2.
